# URETEK Deep Injection (UDI) Research Forensic Photos

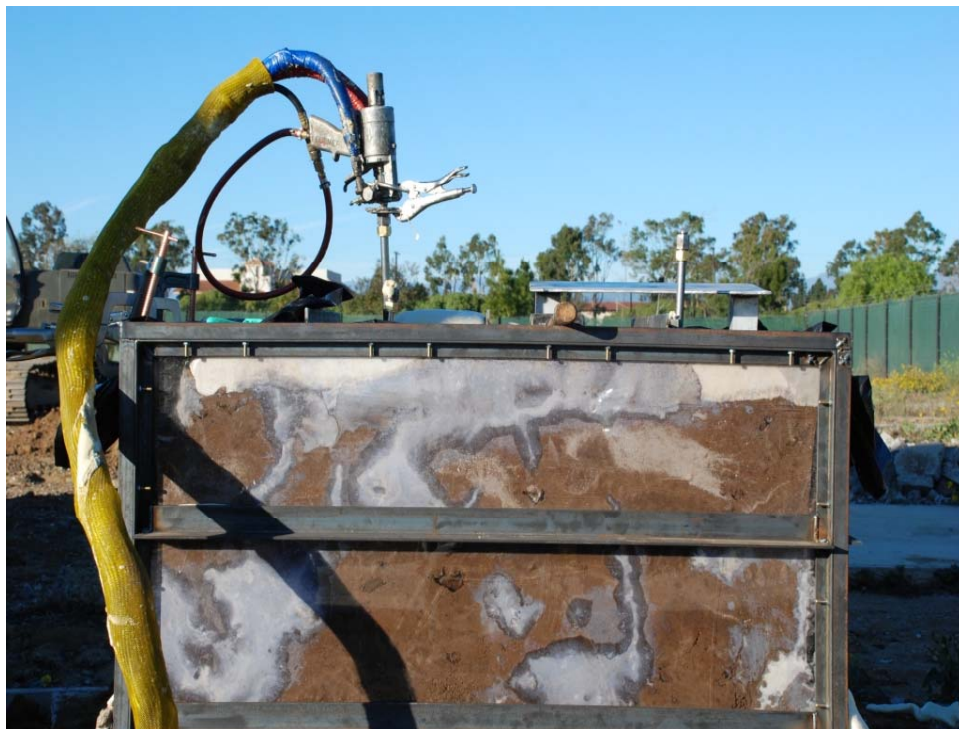
Injection inside steel reinforced, plexi-glass box so material flow could be observed

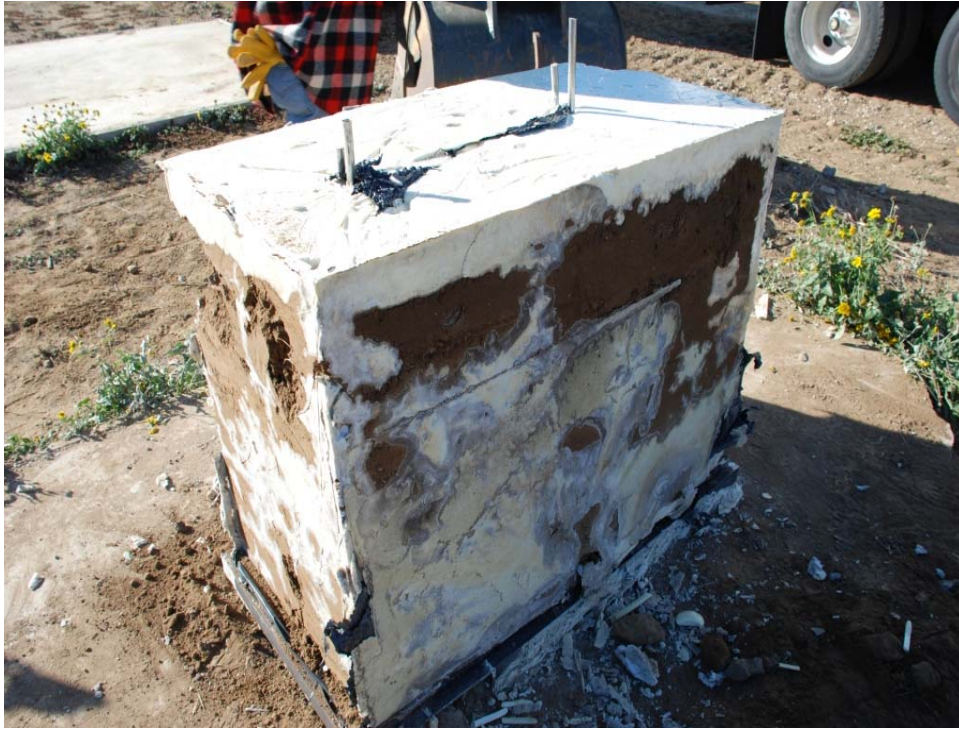
Stabilized soil mass was free-standing after box removed

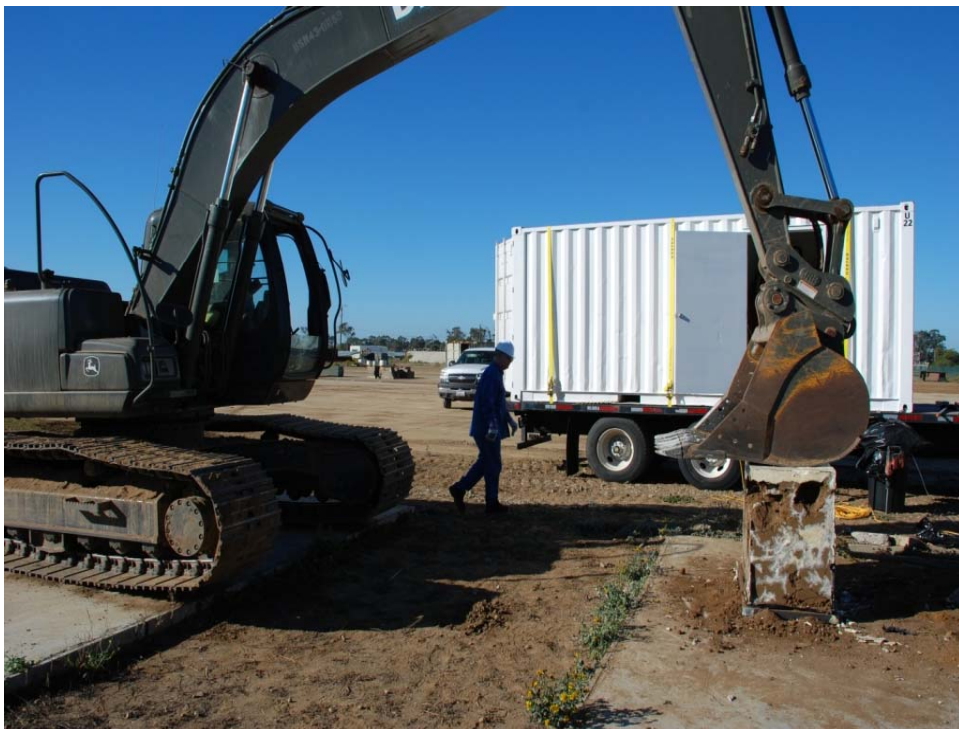
Vertical load applied using an excavator

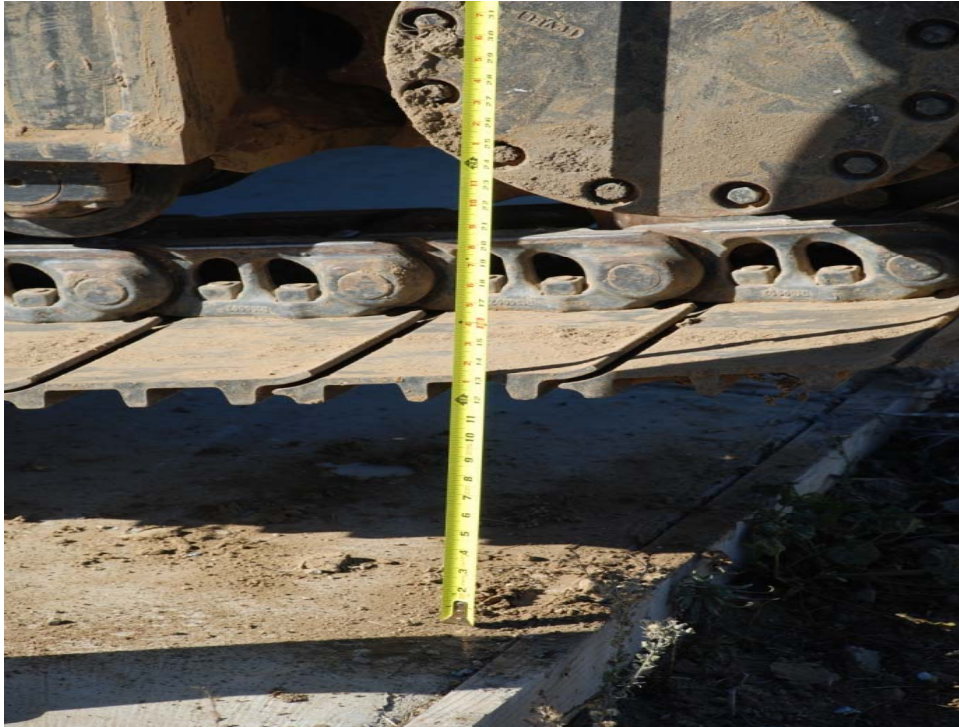
Soil mass would not crush, but excavator was lifted 11 inches

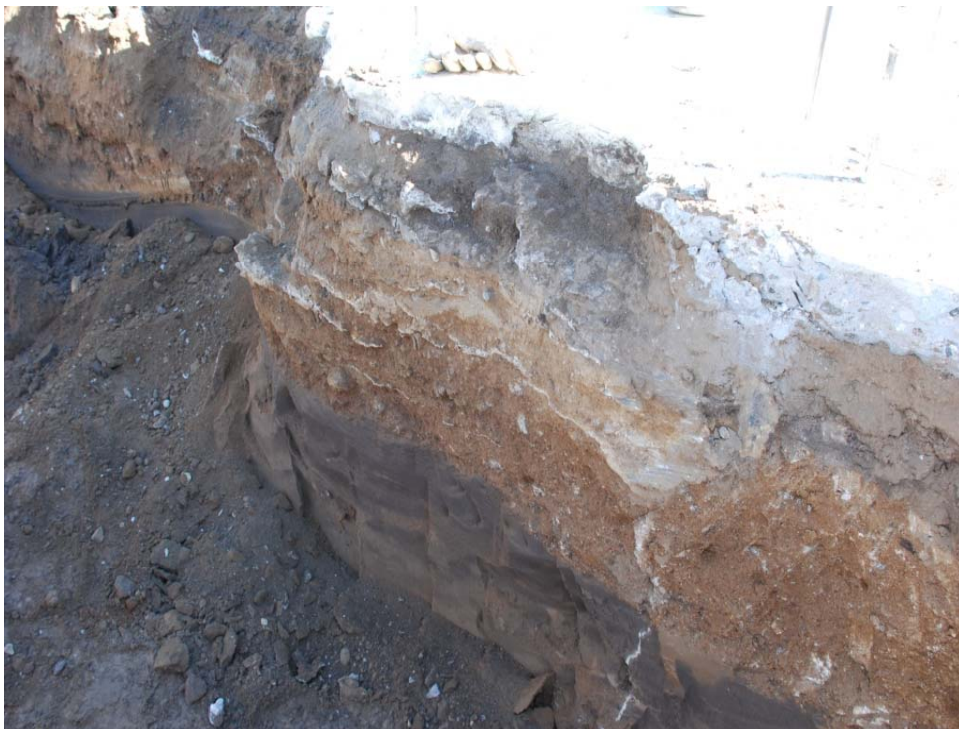
Excavation revealing polyurethane compacting backfill test material and filling voids

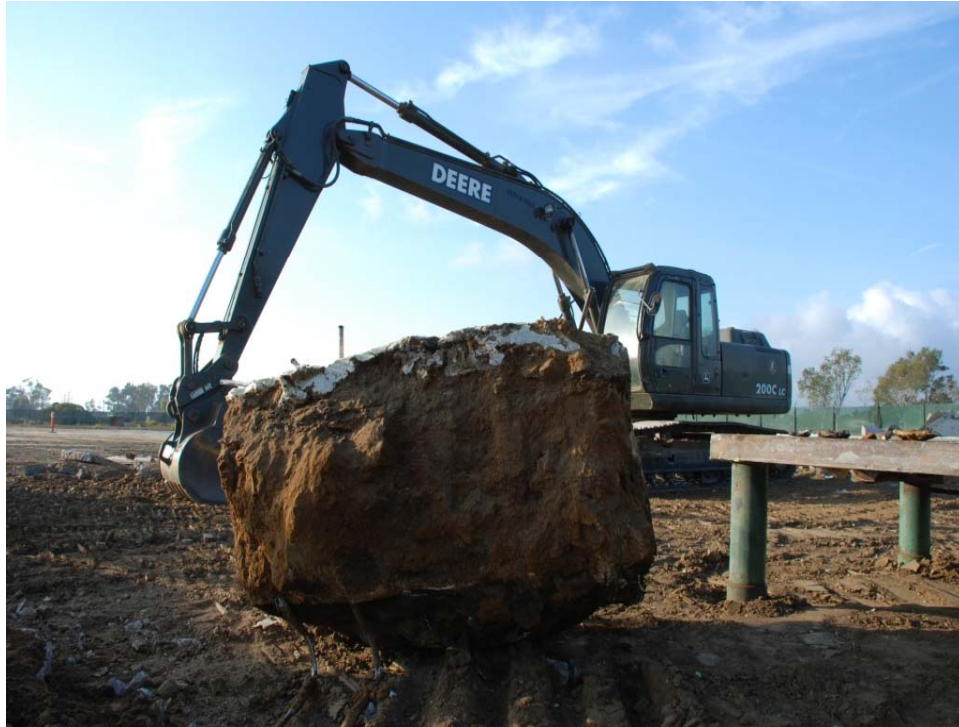
The area of injection was removed intact after the forensic exam
