## Rapid Pool Repair for YMCA in Bellevue, Washington

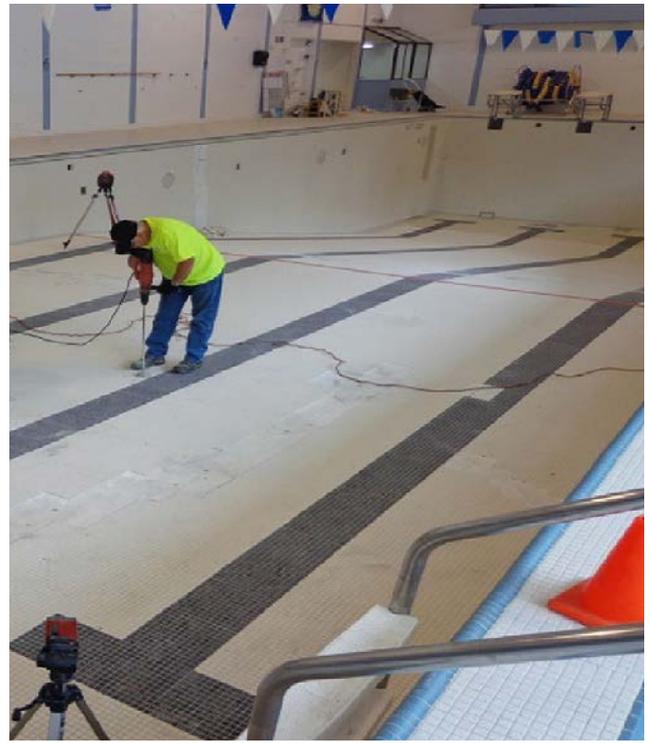
A URETEK crew member drills injection holes in preparation for UDI at the YMCA

UDI was performed in a 4x4 grid pattern using URETEK's 486 Star® polymer to provide void filling, under-sealing for the shell of the pool, and overall support for the entire structure. At various points throughout the application, polymer material was observed escaping through unidentified cracks and voids around the pool, which confirmed the initial assumptions that years of leaching water flow had seriously compromised the soils beneath the swimming pool at the YMCA.

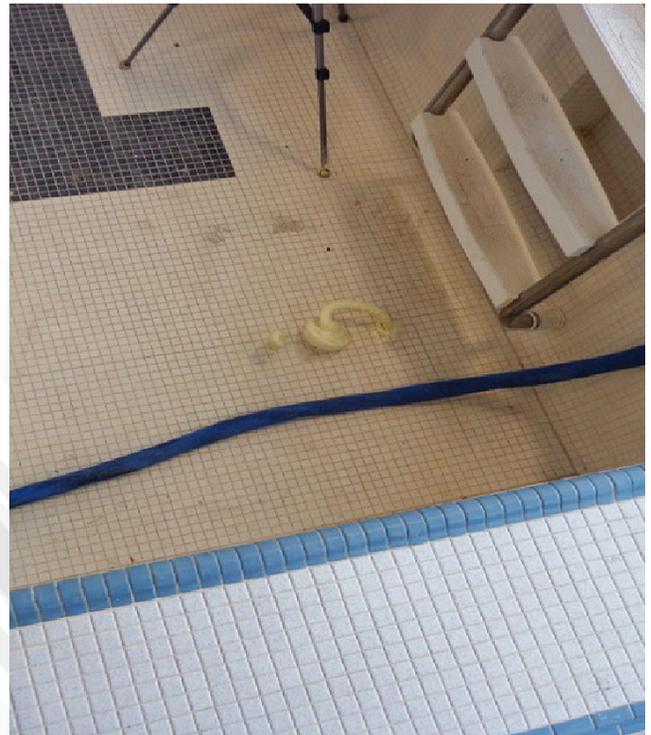
At the YMCA facility in Bellevue, Washington rising water bills were becoming an issue. Administrators noticed a number of small cracks at the edge of the swimming pool and between small tiles at various places around the pool. Closer inspection following selected tile removal revealed voids underneath the cracks. Faced with a serious problem that threatened the facility's main attraction, administrators contacted URETEK to inquire about URETEK Deep Injection® (UDI) as a possible solution.

Small cracks within the pool's tile work indicated underlying problems
